**ASSESSMENT OF PHYSICAL VULNERABILITY OF BUILDINGS  
TO FLOODING IN LILONGWE CITY, MALAWI**

MSc THESIS (GEOGRAPHIC INFORMATION SYSTEMS)

MZUZU UNIVERSITY

MAY 2024

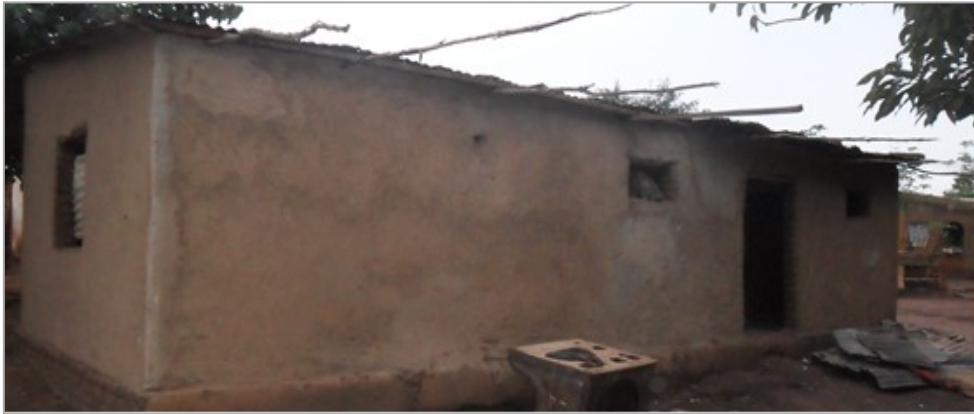
*Figure 13: Some of window materials*  
Source: Fieldwork (2018)

The analysis results also revealed that there were four types of materials for windows and the most common materials for windows were glass. The results of the analysis in Table 7 show that 84.3% of buildings used glass, 9.6% of buildings had wood, and 1.2% of buildings had plastic papers and a mixture of metals and glass as window materials. Figure 13 shows a building with a mixture of window materials.

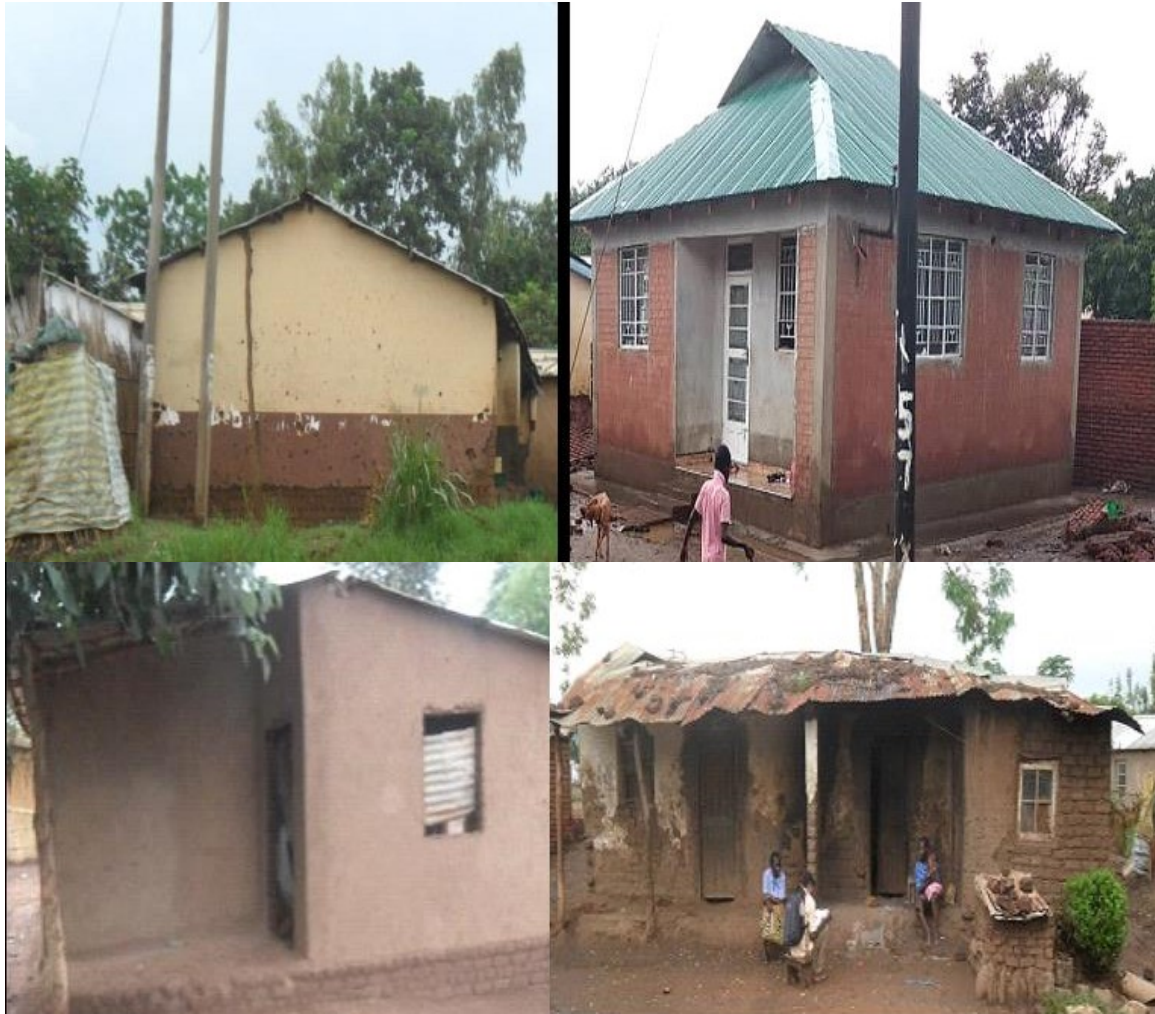
*Figure 16: Some of the buildings in the study area*

Figure 16 shows some of the buildings with different construction materials in the study area.

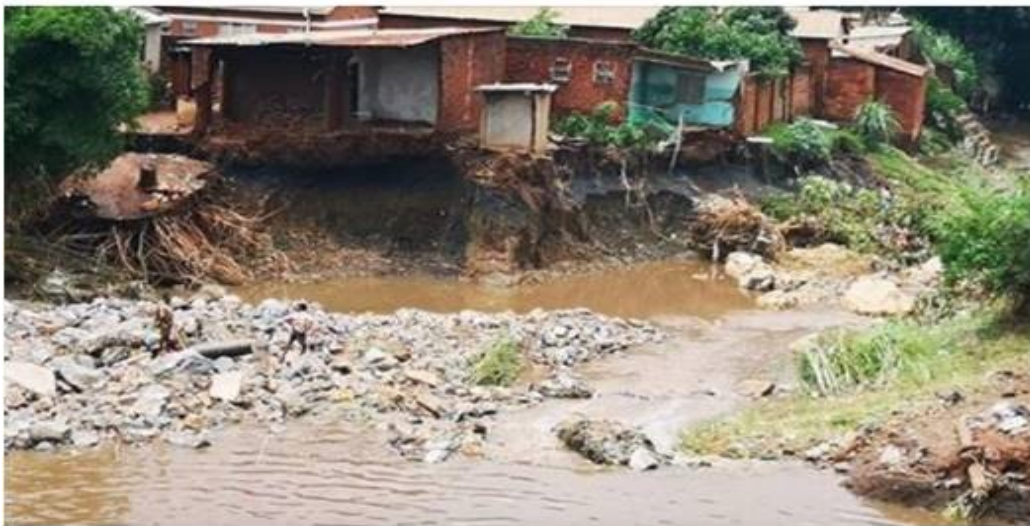
*Figure 18: Buildings close to the river*  
Source: Fieldwork (2019)

Figure 18 shows a building close to the river and Figure 19 shows different terrain characteristics.

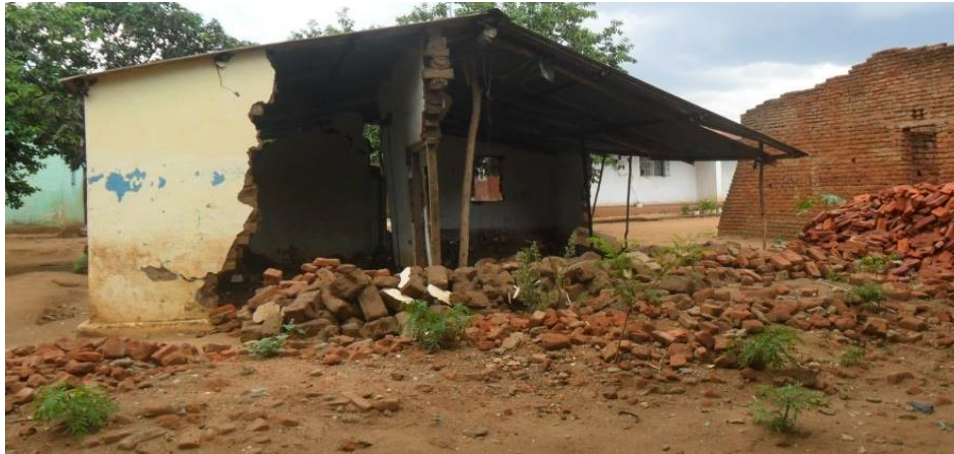
*Figure 23: Collapsed building*

The results of the analysis in Table 17 show that building Type 2 registered relatively high damages (38% of the buildings). However, the other building types had a low percentage of flood damage. Figure 23 shows a collapsed building due to flood impacts. Figure 24 shows a map of different magnitudes of damage of buildings, deep red dot represents buildings that registered high damage while light red dots show buildings with low damage.

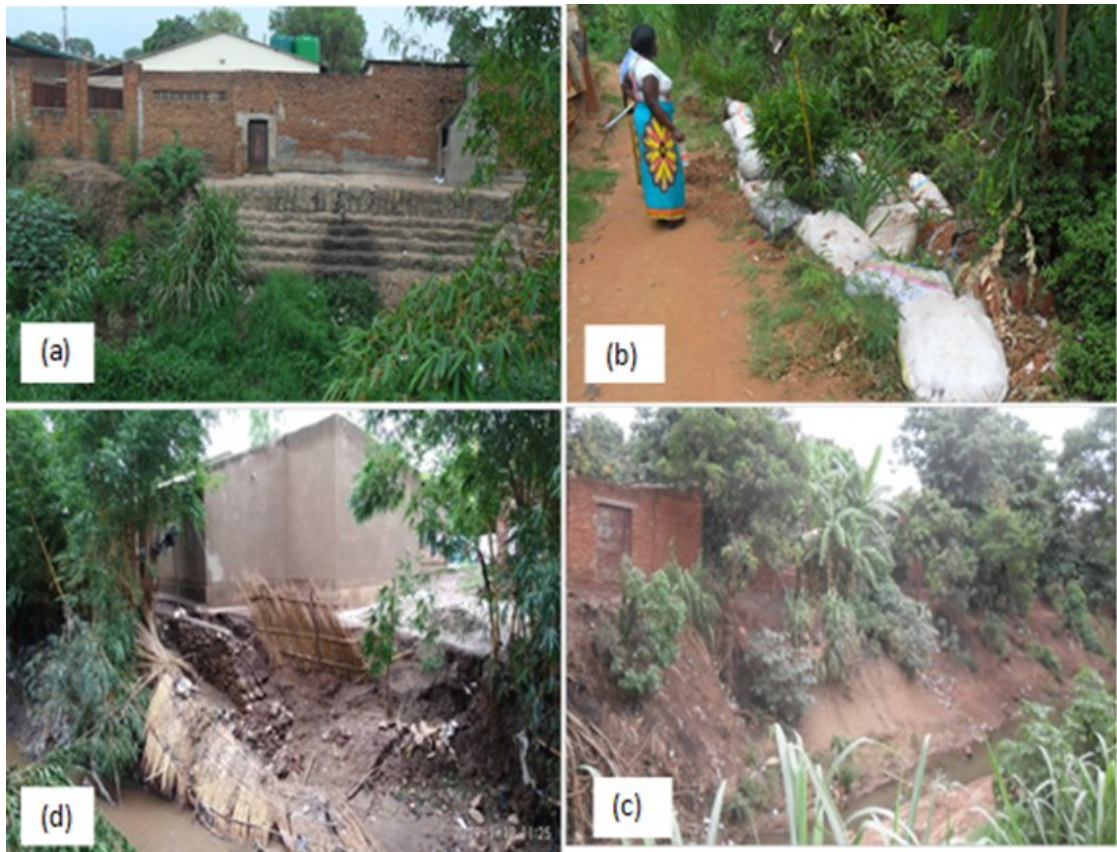
*Figure 27: Some of the building protection measures*

| Source of data | Type of protection and measures | Actions applied | Rationale for choice | Literature |
|---|---|---|---|---|
| | Coping strategies or temporary flood proof measures. | Non-structural measures: Piling sandbags, digging storm drains, covering walls of buildings with plastic sheets, and cleaning storm drains. | Keeping out the floodwater from buildings and lessening damages. | Sagala (2006):Fatemi et al.(2020); Cordero et al.(2017); Mirajkar (2021) |
