# Analysis of the Impact of Aquatic Weeds in the Shire River on Generation of Electricity in Malawi: A Case of Nkula Falls Hydro-Electric Power Station in Mwanza District, Southern Malawi

A study was carried out to analyse the extent to which diverse species of aquatic weeds that have proliferated in the Shire River in Malawi in recent years affect the generation of electricity at Nkula Hydro-Electric Station in Mwanza District of the southern region of the country. Specifically, the study endeavoured to establish whether frequent power interruptions that Malawi is facing are the result of the problems caused by aquatic weeds in the Shire River which are believed to disturb proper functioning of the machines at the power station. Study results revealed that as much as the aquatic weeds impede power generation such as blocking the turbines, problems of low power generation that result into frequent and persistent load shedding are not entirely due to aquatic weeds. Problems of inefficient machines and shut down of machines are due to serving, which appeared to be the major cause.

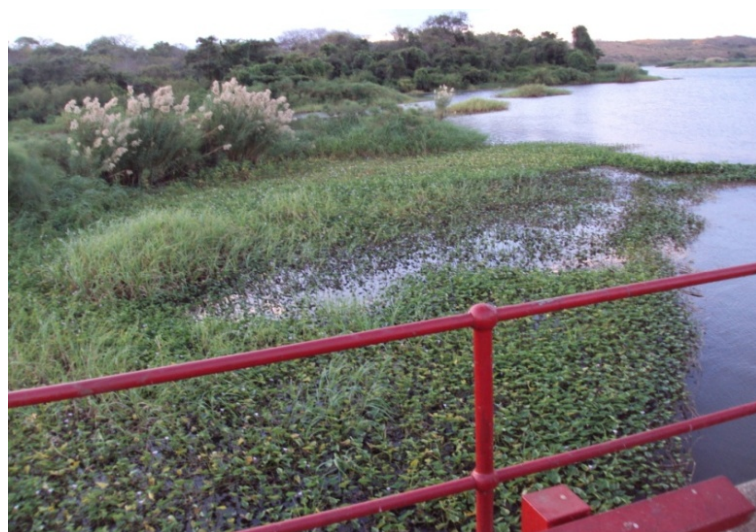
**Figure 1.** A combination of several grass species—Water hyacinth, reeds, water lettuce and others at the Nkula Falls Intake.

Electricity is a backbone to the development of a country. Many manufacturing industries use electricity for their production and people rely on electricity for their daily domestic jobs such as cooking. Hospitals too need electricity for their day-to-day activities. The need for electricity can therefore not be undermined. However, Malawi has recently been facing intermittent electricity blackouts and the Electricity Supply Corporation of Malawi (ESCOM), which provides about 98% of the electricity in the country [1] [2] is facing a great challenge to meet the demand for power. Its major hydro-electricity power (HEP) station at Nkula Falls along the Shire River, together with other HEPs of Tedzani and Kapichira Falls along the same river are not able to generate enough electricity to meet the ever increasing demand. Only 8% of the population in Malawi has access to electricity [3]. Malawi is in fact, one of the least electrified countries in the SADC region, with an average per capita consumption of 111kWh per annum, rated among the lowest in the world [4]. [5] reported that Malawi's power outages are the highest in Africa. [1] reported that Malawi's installed generation capacity is approximately 287 megawatts, of which only about 267 megawatts is available against an estimated demand of approximately 325 megawatts. It further reported that with a projected peak demand of 757 megawatts by 2020, electricity generation capacity needs to increase at an average annual growth rate of 10%. According to [6], in 2005 alone, Nkula Power Station lost 349.19 hours resulting into load shedding and consequently loss of revenue for ESCOM. [7] estimated that the country is losing 215.6 million dollars a year due to the power outages. These power shortage problems reached a climax when one of the consumer rights body in Malawi—the Consumer Association of Malawi (CAMA) challenged ESCOM in court to stop their motto of “*power all day everyday*” as this did not reflect their output. ESCOM eventually changed its motto to read “*towards power all day everyday*”. While ESCOM admits that its power generation capacity is below consumer demand, it has directed the problem of persistent power outages on the weeds in the Shire River (Figure 1) where Nkula Hydro-electricity power station is built.

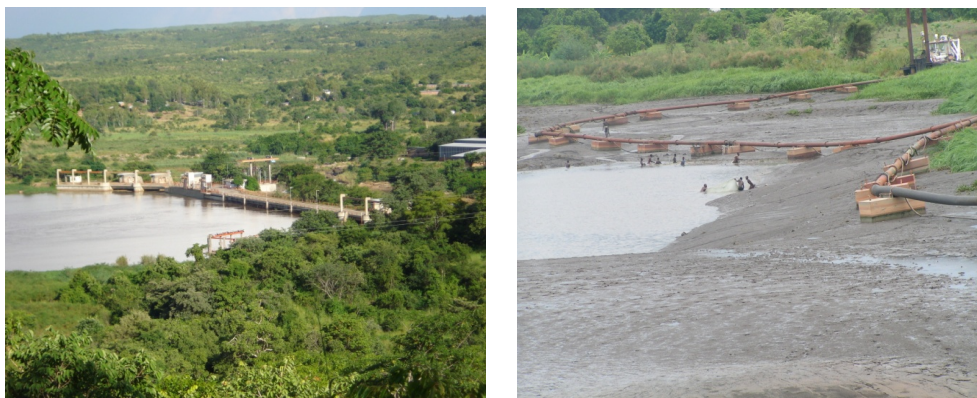
Figure 2. The water intake dam at Nkula Falls on the Shire River (left); heavy siltation (right).

Since late 1990s, aquatic weeds which have not caused any environmental concern in the Shire River have found their way into the power generation plant at Nkula Falls HEP [2]. Increase in the aquatic weeds has resulted into an increase in floating aquatic weeds and debris in addition to siltation at the intake ponds (Figure 2).

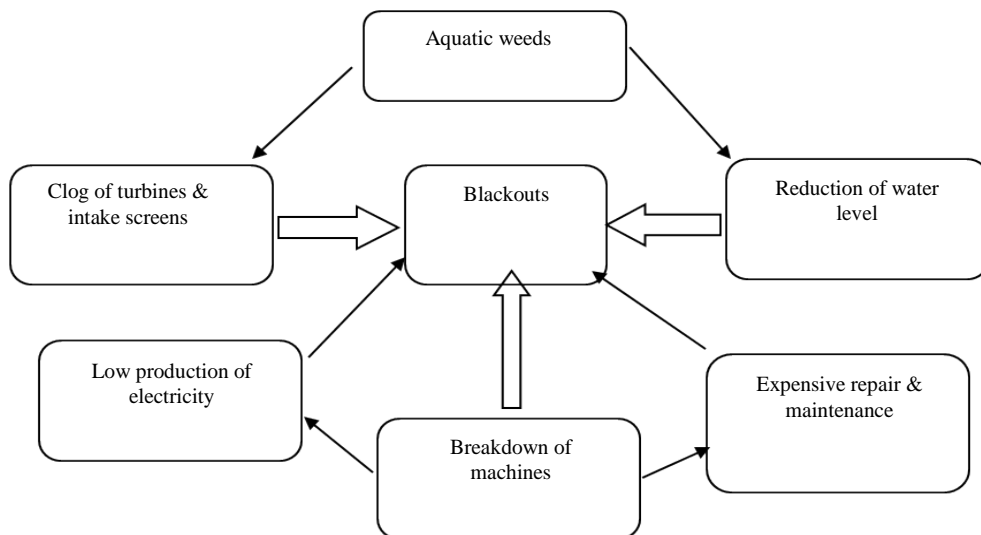
Figure 3. Theoretical model (modified from [6] [8] [11]).

Theoretical model gives the possible reasons that could explain some of the causes of blackouts. For example, the presence of aquatic weeds causes clogging of turbines and intake screens and reduction of water level consequently resulting in frequent blackouts. The machines used are old and commonly breakdown resulting in low production of electricity which also result in blackout.

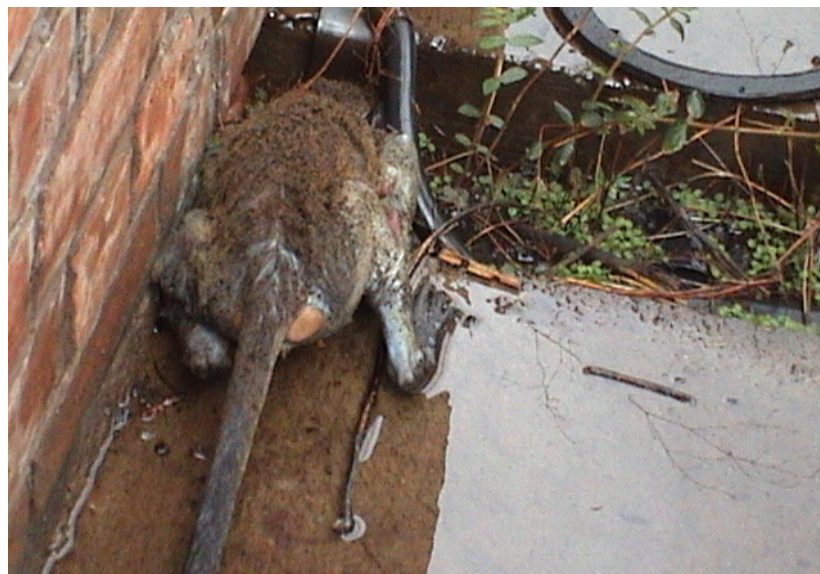
Figure 6. A monkey that landed on an ESCOM transformer resulting into power cut (Photo kindly provided by Nkula HEP Station personnel).

when nearly all parts in Malawi do not receive rains—dry season, suggested that problems of aquatic weeds occur not only during rainy season as is reported by ESCOM. Probably this could be directly related to how much rain was received from the river’s catchment area. The high power production losses in November (Figure 4) due to both trash and other reasons could be attributed to the fact the southern region of Malawi receives rains much earlier than the central and northern regions of the country. The other causes to loss in power generation included repairing of machines such as greasing, runner repairs, brush gear sparking and general breakdown of the machines. Other minor reasons included power disruption by vandalism of ESCOM transformers and animals being short-circuited on power lines (Figure 6).

ESCOM equipment is costly hence any type of damage is significant. That is why scenarios of animals such as monkeys falling and being electrocuted over electric wires cannot be under estimated (Figure 6). Vandalism of ESCOM equipment also continues to be on the rise resulting into the company spending a lot of money maintaining its equipment [17].
